# Thermography Applied to Damage Diagnosis over Monuments and Ancient Constructions

## ABSTRACT

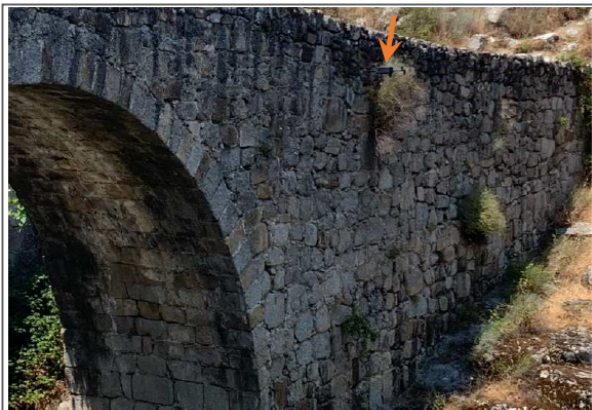
**Figure 5:** Drone equipped with a thermal imaging camera, approaching a medieval bridge (Puente del Grajal) for inspection (photograph by the autor).

As a complement to what we have exposed in the previous section, in recent years thermographic cameras have been incorporated into drones. This is what we know as aerial thermography: to the experience gained inspecting buildings with drones we now add thermography [7,8]. Thus, we can see in Figure 5 a quadcopter drone approaching a medieval bridge for inspection. In this case, it is the Grajal Bridge, visually inspected by the author [8,9].

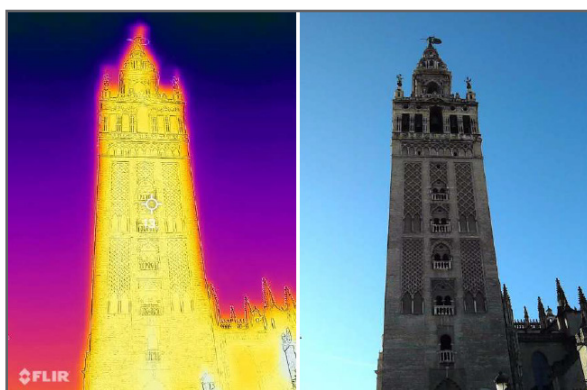
**Figure 8:** thermographic analysis of the north façade of the Giralda bell tower. We can see, on the left, the photograph taken by a thermographic camera and, on the right, the same photograph taken by a photographic camera. We can see, on the left, the photograph taken by a thermographic camera and, on the right, the same photograph taken by a photographic camera (photographs by the author).

With it, we have analyzed the Giralda, the bell tower of the Seville Cathedral (Figure 8 and Figure 9), the Torre del Oro in Seville too (Figure 10), the bell tower of the Oviedo Cathedral (Figure 11), the Roman lighthouse Tower of Hercules in La Coruña (Figure 12 and Figure 13), fragments of the Monastery of El Escorial (Figure 14) or the Palma de Mallorca Cathedral (Figure 15 and Figure 16), to give just a few examples. The images collected below illustrate the usefulness of thermography for this purpose.

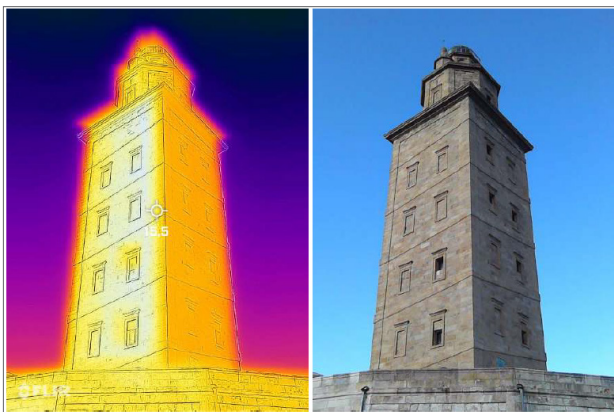
**Figure 12:** Thermographic analysis of the Roman lighthouse Torre de Hércules, in La Coruña. We can see, on the left, the photograph taken by a thermographic camera and, on the right, the same photograph taken by a photographic camera (photographs by the author).

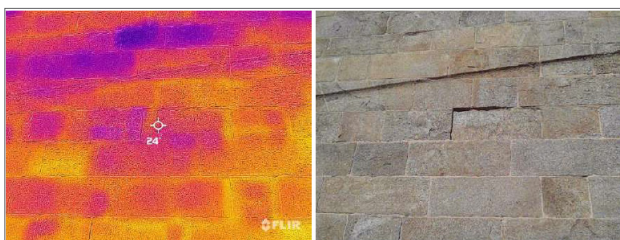
**Figure 13:** Detailed thermographic analysis of the constituent materials (granite with mortar) of a fragment of the façade of the Torre de Hércules Roman lighthouse. We can see, on the left, the photograph taken by a thermographic camera and, on the right, the same photograph taken by a photographic camera (photographs by the author).

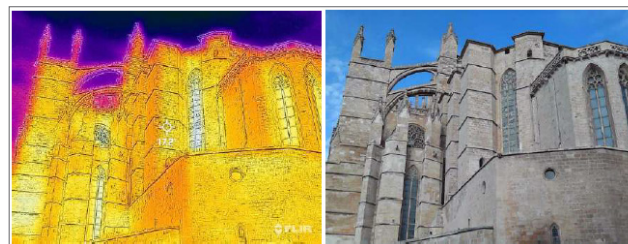
**Figure 16:** Exterior thermographic analysis of the chevet of the Palma de Mallorca Cathedral (photographs by the author).
